PORTSMOUTH COAST GUARD STATION STORAGE SHED (Boathouse) HABS No. NC-358-A
Cape Lookout National Seashore HABS
Portsmouth Vicinity
Carteret County
North Carolina

### HISTORIC AMERICAN BUILDINGS SURVEY

#### PORTSMOUTH COAST GUARD STATION STORAGE SHED (Boathouse) HABS No. NC-358-A

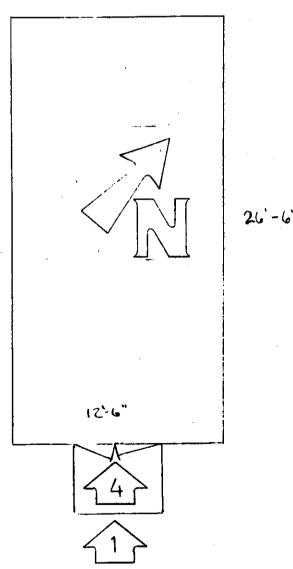
Photo Positions

Not Able to take prefuers from N side due to Versetnina.

50 degaces

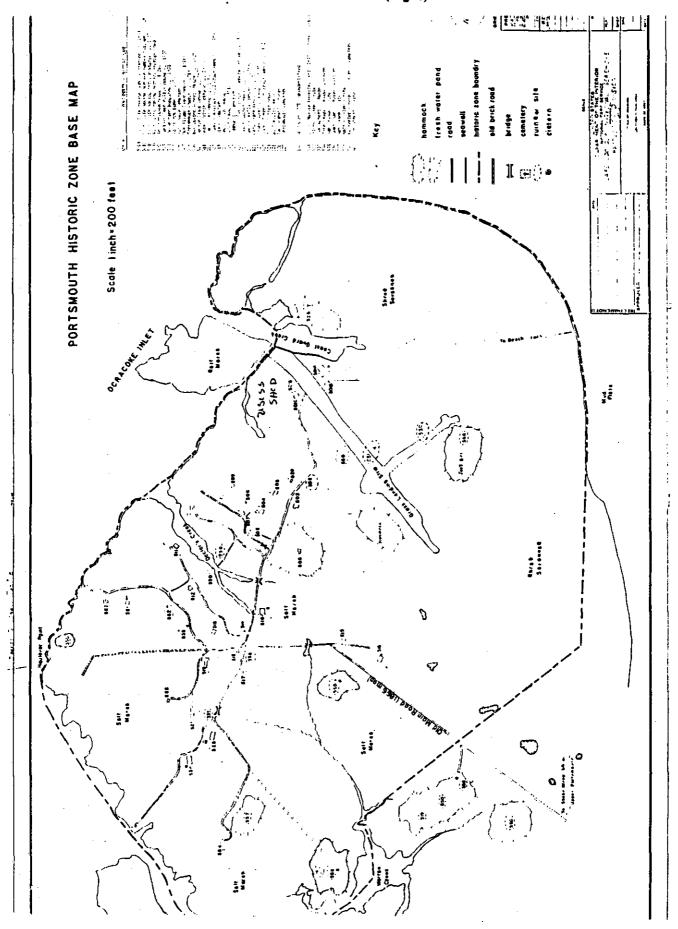
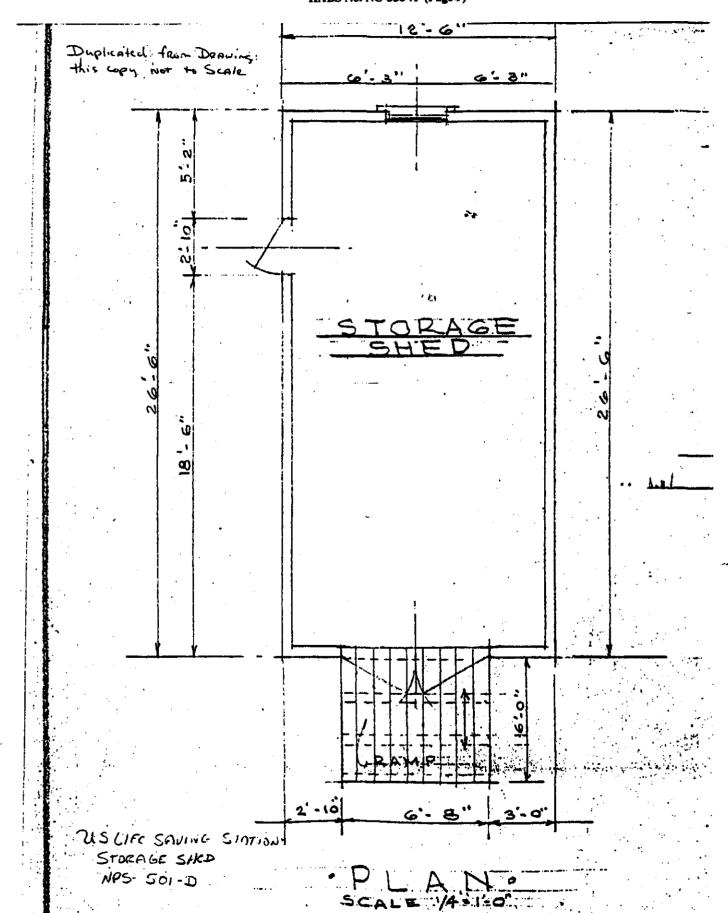
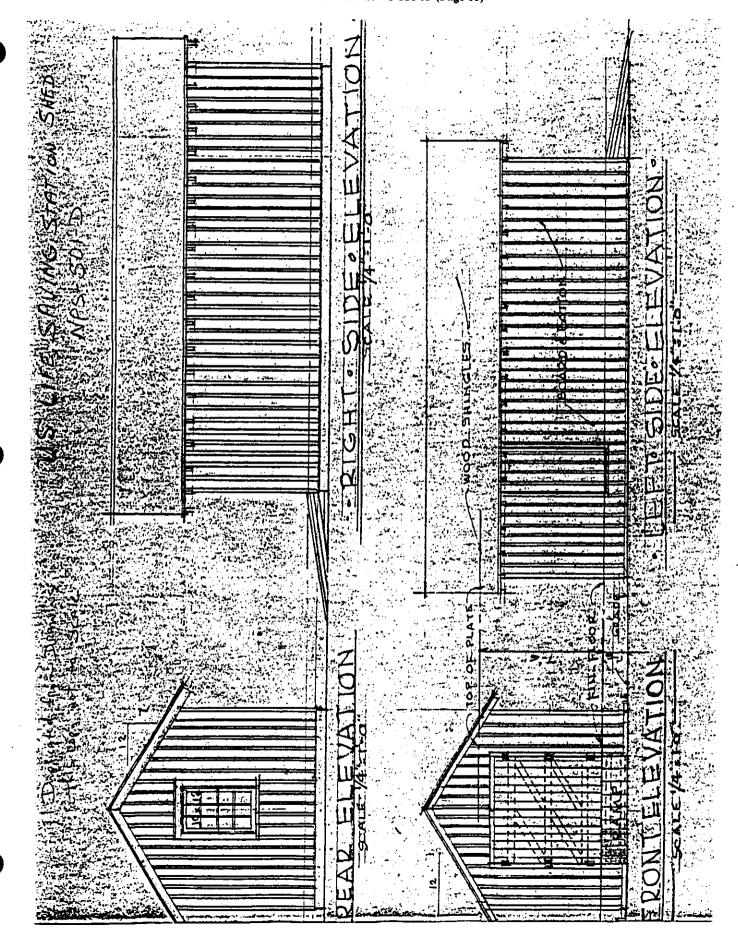
US LIFE SAUING STOFAGE SHED NPS # 501-D

This 12' 6" wide by 26' 6" long wood structure is a simple board and batten building with gables and overhanging eaves. This, essentially one-room, shed does not appear to have been added to or greatly modified in any manner. A large (6' 8" wide) double door in one end provided access for the boat(s) that were stored in it during the Coast Guard period. A window is at the opposite end of the building. Floor joists are 3" x 10" timbers; studs are 2" x 4" and 4" x 4"; rafters are both 2" x 4" and 2" x 6". Detailed drawings are permanently filed in archives of Cape Lookout National Seashore. Photographs, detailed drawings and an "Architectural Data Form" (Form 10-920) were accepted in January 1989 by the Southeast Regional Office of the National Park Service for submission to the Library of Congress under the Historic American Buildings Survey process.
